MSFC Safety Bulletin

Loss of Consciousness in Autoclave

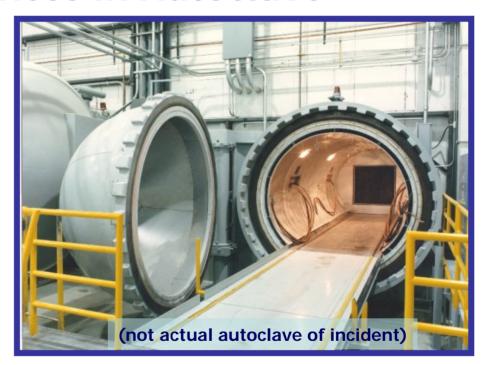
- While conducting non-NASA related activities, employees were having difficulty performing pressure and vacuum leak checks at a MSFC contractor autoclave.
- ➤ The employee turned off the pressurization, opened the door halfway, listened and looked for an alarm before entering the autoclave to investigate.
- ➤ After entering approximately 40 feet, the employee felt faint due to lack of Oxygen and tried to exit. A co-worker outside the autoclave heard the employee fall, ran in and pulled the employee out. Fortunately, the employee did regained consciousness and both the employee and rescuer survived this incident.
- This was a "very" close call! *
- The lack of a failsafe hazard monitoring system and improper procedures and the employee opening the autoclave door only halfway were identified as causes of this incident.

Additional warning lights and alarms, procedure changes, retraining, and use of portable O2 sensors are being implemented to keep this from recurring.
